June 17, 2010

Re: **Special Notice to Olympus Users of STERRAD Sterilization Systems:  
Proper Venting of Olympus Fiberoptic/Video Endoscopes using the ETO or  
Water Resistant Cap**

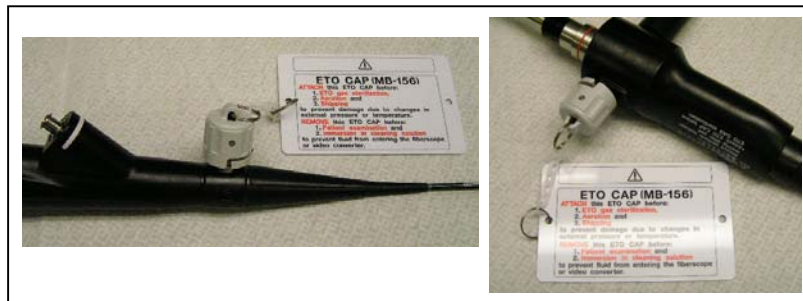
Fig. 1. ETO cap attachment to Olympus fiberoptic/video endoscopes

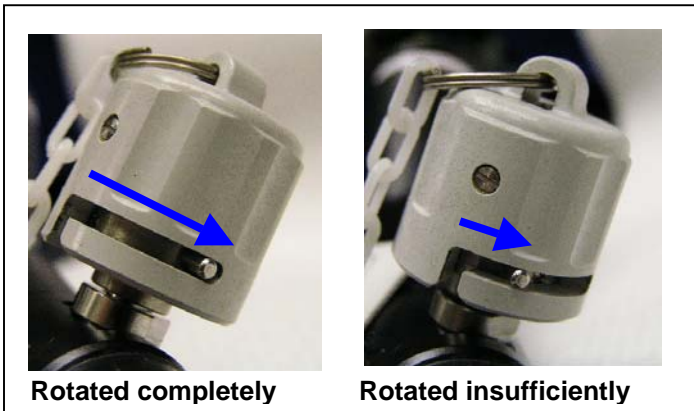
Fig. 3. Proper ETO cap attachment

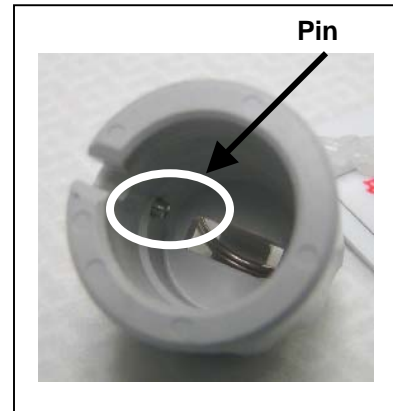
Fig. 4. ETO cap pin

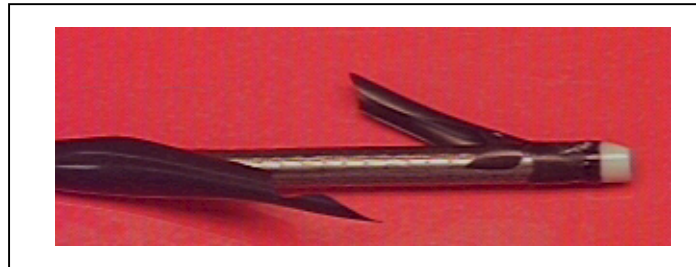
This notice is to inform customers that Olympus has received reports of inadvertent damage to Olympus fiberoptic/video endoscopes as a result of improper reprocessing in a STERRAD Sterilization System. Specifically, Olympus endoscopes were damaged as a result of failure to properly vent the endoscope by attaching the ETO cap to fiberoptic/video endoscopes, or removing the water resistant cap from video endoscopes prior to sterilization in a STERRAD Sterilization System. For proper reprocessing in a STERRAD Sterilization System, attach the ETO Cap to fiberoptic/video endoscopes (Fig. 1) or remove the Water Resistant Cap from video endoscopes (Fig. 2). If attaching an ETO cap to vent the endoscope, ensure that the ETO Cap is rotated completely (Fig. 3). Also, verify that the pin of the ETO cap is not damaged (Fig. 4). Otherwise, the vacuum generated in the chamber of the STERRAD Sterilization System will cause the bending section cover to rupture (Fig. 5).

Fig. 5. Bending section rupture
