**RE: Compatibility of Olympus Flexible Endoscopes with Sporox and Sporox II
(Covered Models: All fiberoptic and videoendoscopes)**

Illustrations of Endoscope Damage After Repeated Exposure to SPOROX® Sterilizing & Disinfecting Solution

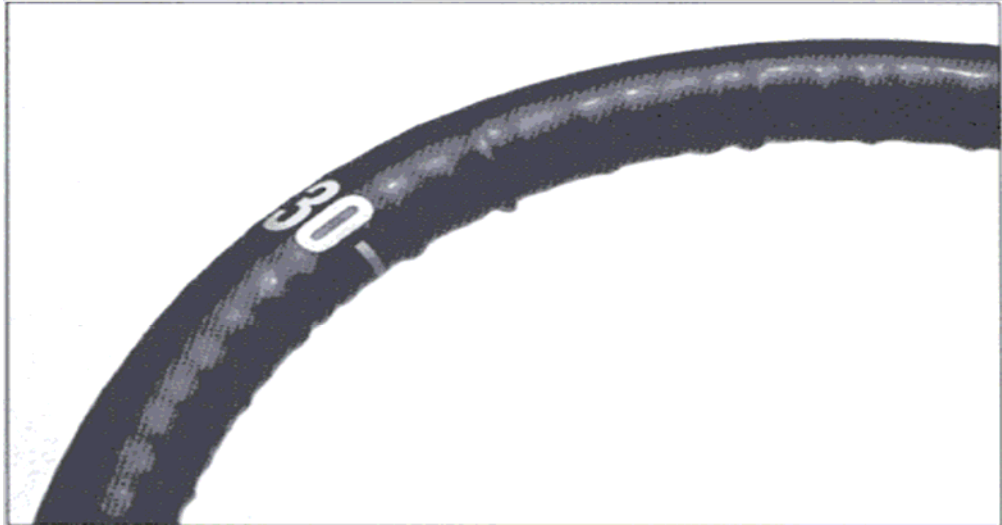
Severe buckling of the insertion tube on a CF-140L colonoscope. The outer covering of the insertion tube has detached from the metal substructure below. This results in a loose, wrinkled outer cover. The wrinkles are particularly evident when the insertion tube is flexed.

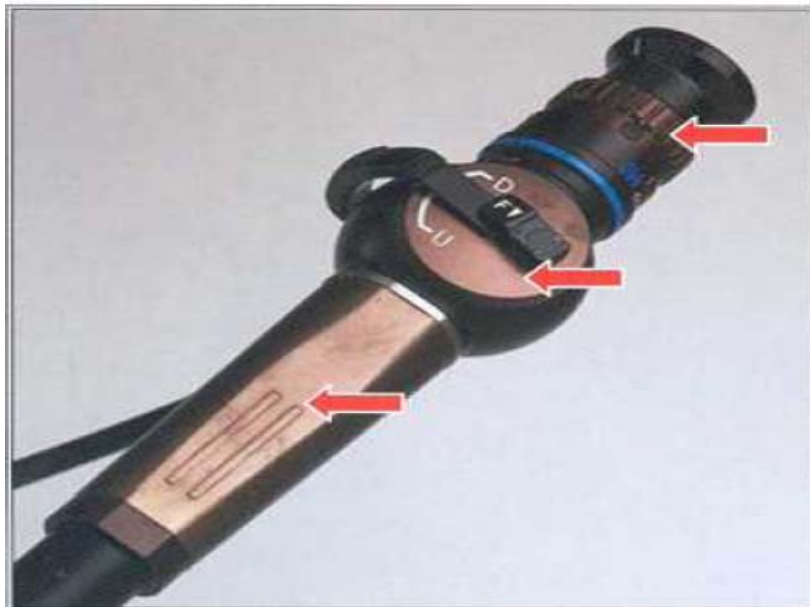
Cosmetic damage to an ENF-P3 rhinolaryngoscope. The black anodized coating on various parts of the control section has been removed, resulting in a silvery and/or golden tinge. Similar loss of anodization is usually observed on portions of the light guide connector.

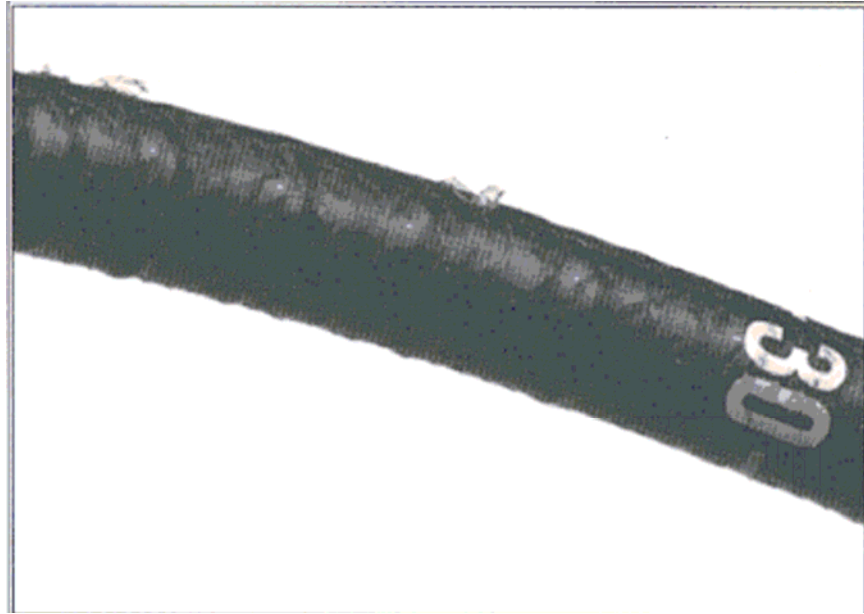
The normally smooth, shiny, clear outer coating on this GIF-140 gastroscope is now cracked and crazed. The topcoat of the insertion tube has started to peel as it deteriorates.

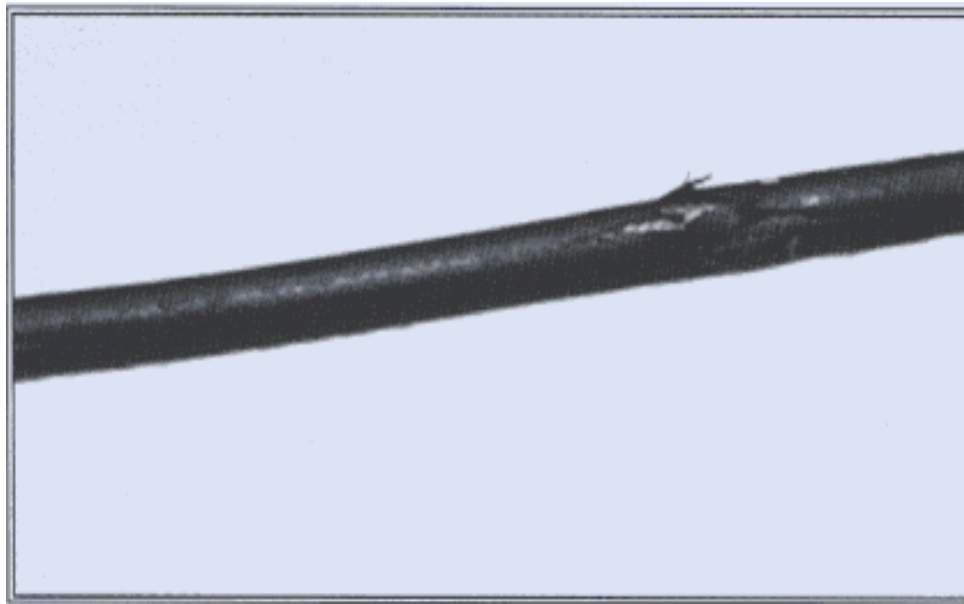
The insertion tube on this ENF-P3 shows erosion of the top shiny layer. Deterioration of the resin results in a roughened surface, erosion of the white markers, and finally tears in the coating itself.
