March 23, 2009

Re: **Proper Attachment of Olympus Bronchoscope Single-Use Suction Valves (MAJ-209)**

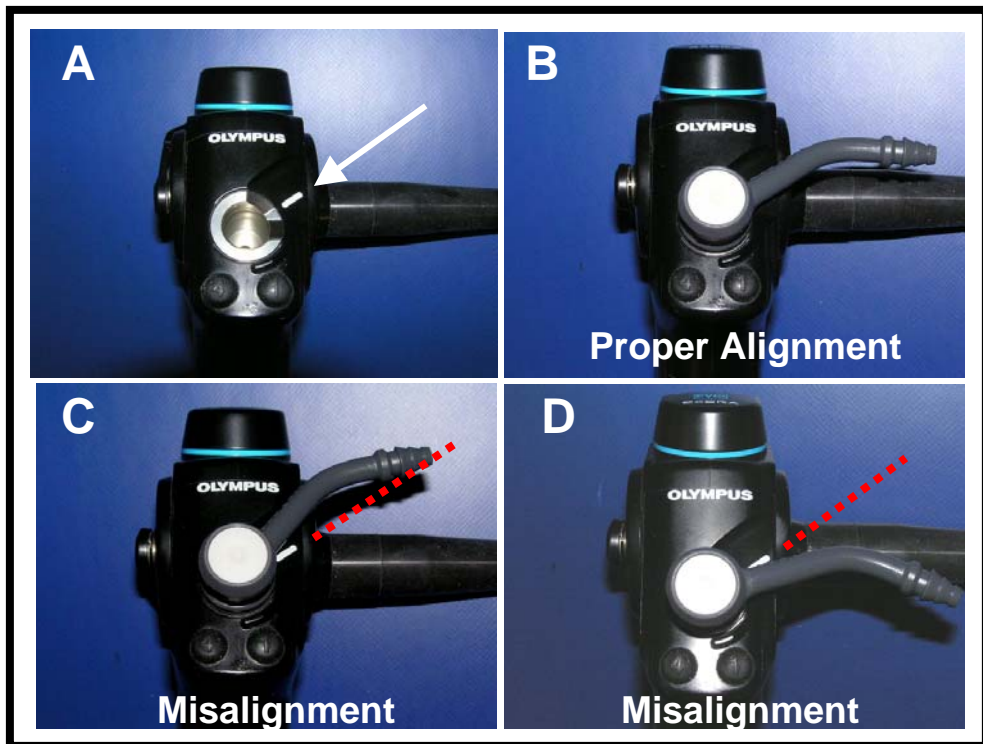
Figure 1: Proper alignment of the suction valve. Panel A shows the white mark (arrow) for alignment of the suction valve arm. Proper alignment is exhibited in Panel B. Panels C & D show misalignment of the suction valve arm with the white mark on the control body. Red-dashed line indicates the proper alignment for the valve arm.

To properly attach the suction valve, place the valve in the suction cylinder with the valve arm aligned with the white mark (Arrow, Fig. 1A) located in the 2 o'clock position on the suction cylinder (Arrow, Fig. 1A). The valve arm must be properly aligned when attaching the valve to the bronchoscope (Fig. 1B). Misalignment of the arm (Figs. 1C & 2D) will prevent the valve from fully seating in the valve housing, enabling the valve to detach during use.

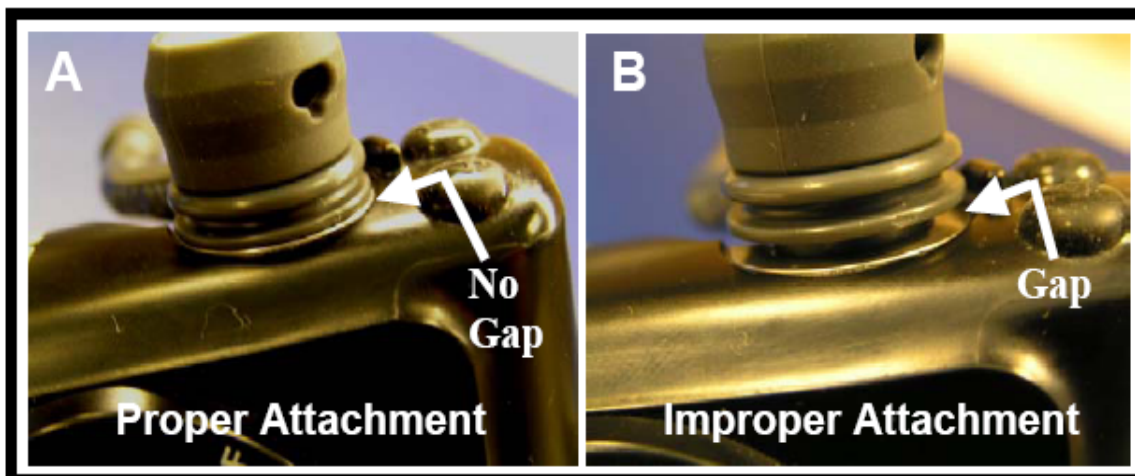
Figure 2: Proper attachment of the suction valve to the bronchoscope. Panel A shows the base of the suction valve contacting the top of the suction cylinder. Improper alignment is exhibited in Panel B, where a gap still exists between the base of the suction valve and the top of the suction cylinder.

After proper alignment, press firmly on the suction valve's top surface (white button) until the base of the suction valve snaps into place AND becomes flush with the top of the suction cylinder (Fig. 2A). Even though the suction valve may seem to click into place, it may not be fully seated in the suction cylinder (Fig. 2B). Therefore, after attaching the valve to the suction cylinder, always visually inspect the attachment to verify that the base of the valve is in contact with the suction cylinder. If the valve has not mated with the suction cylinder surface, the valve is not properly attached and may easily become loose, and detach from the bronchoscope during use.
